REPORT OF INVESTIGATION
(UNDERGROUND COAL MINE)
FATAL FALL OF RIB (OUTBURST) ACCIDENT

Deer Creek Mine (ID No. 42-00121)
Emery Mining Corporation
Huntington, Emery County, Utah

Injured: August 12, 1982
Died: September 6, 1982

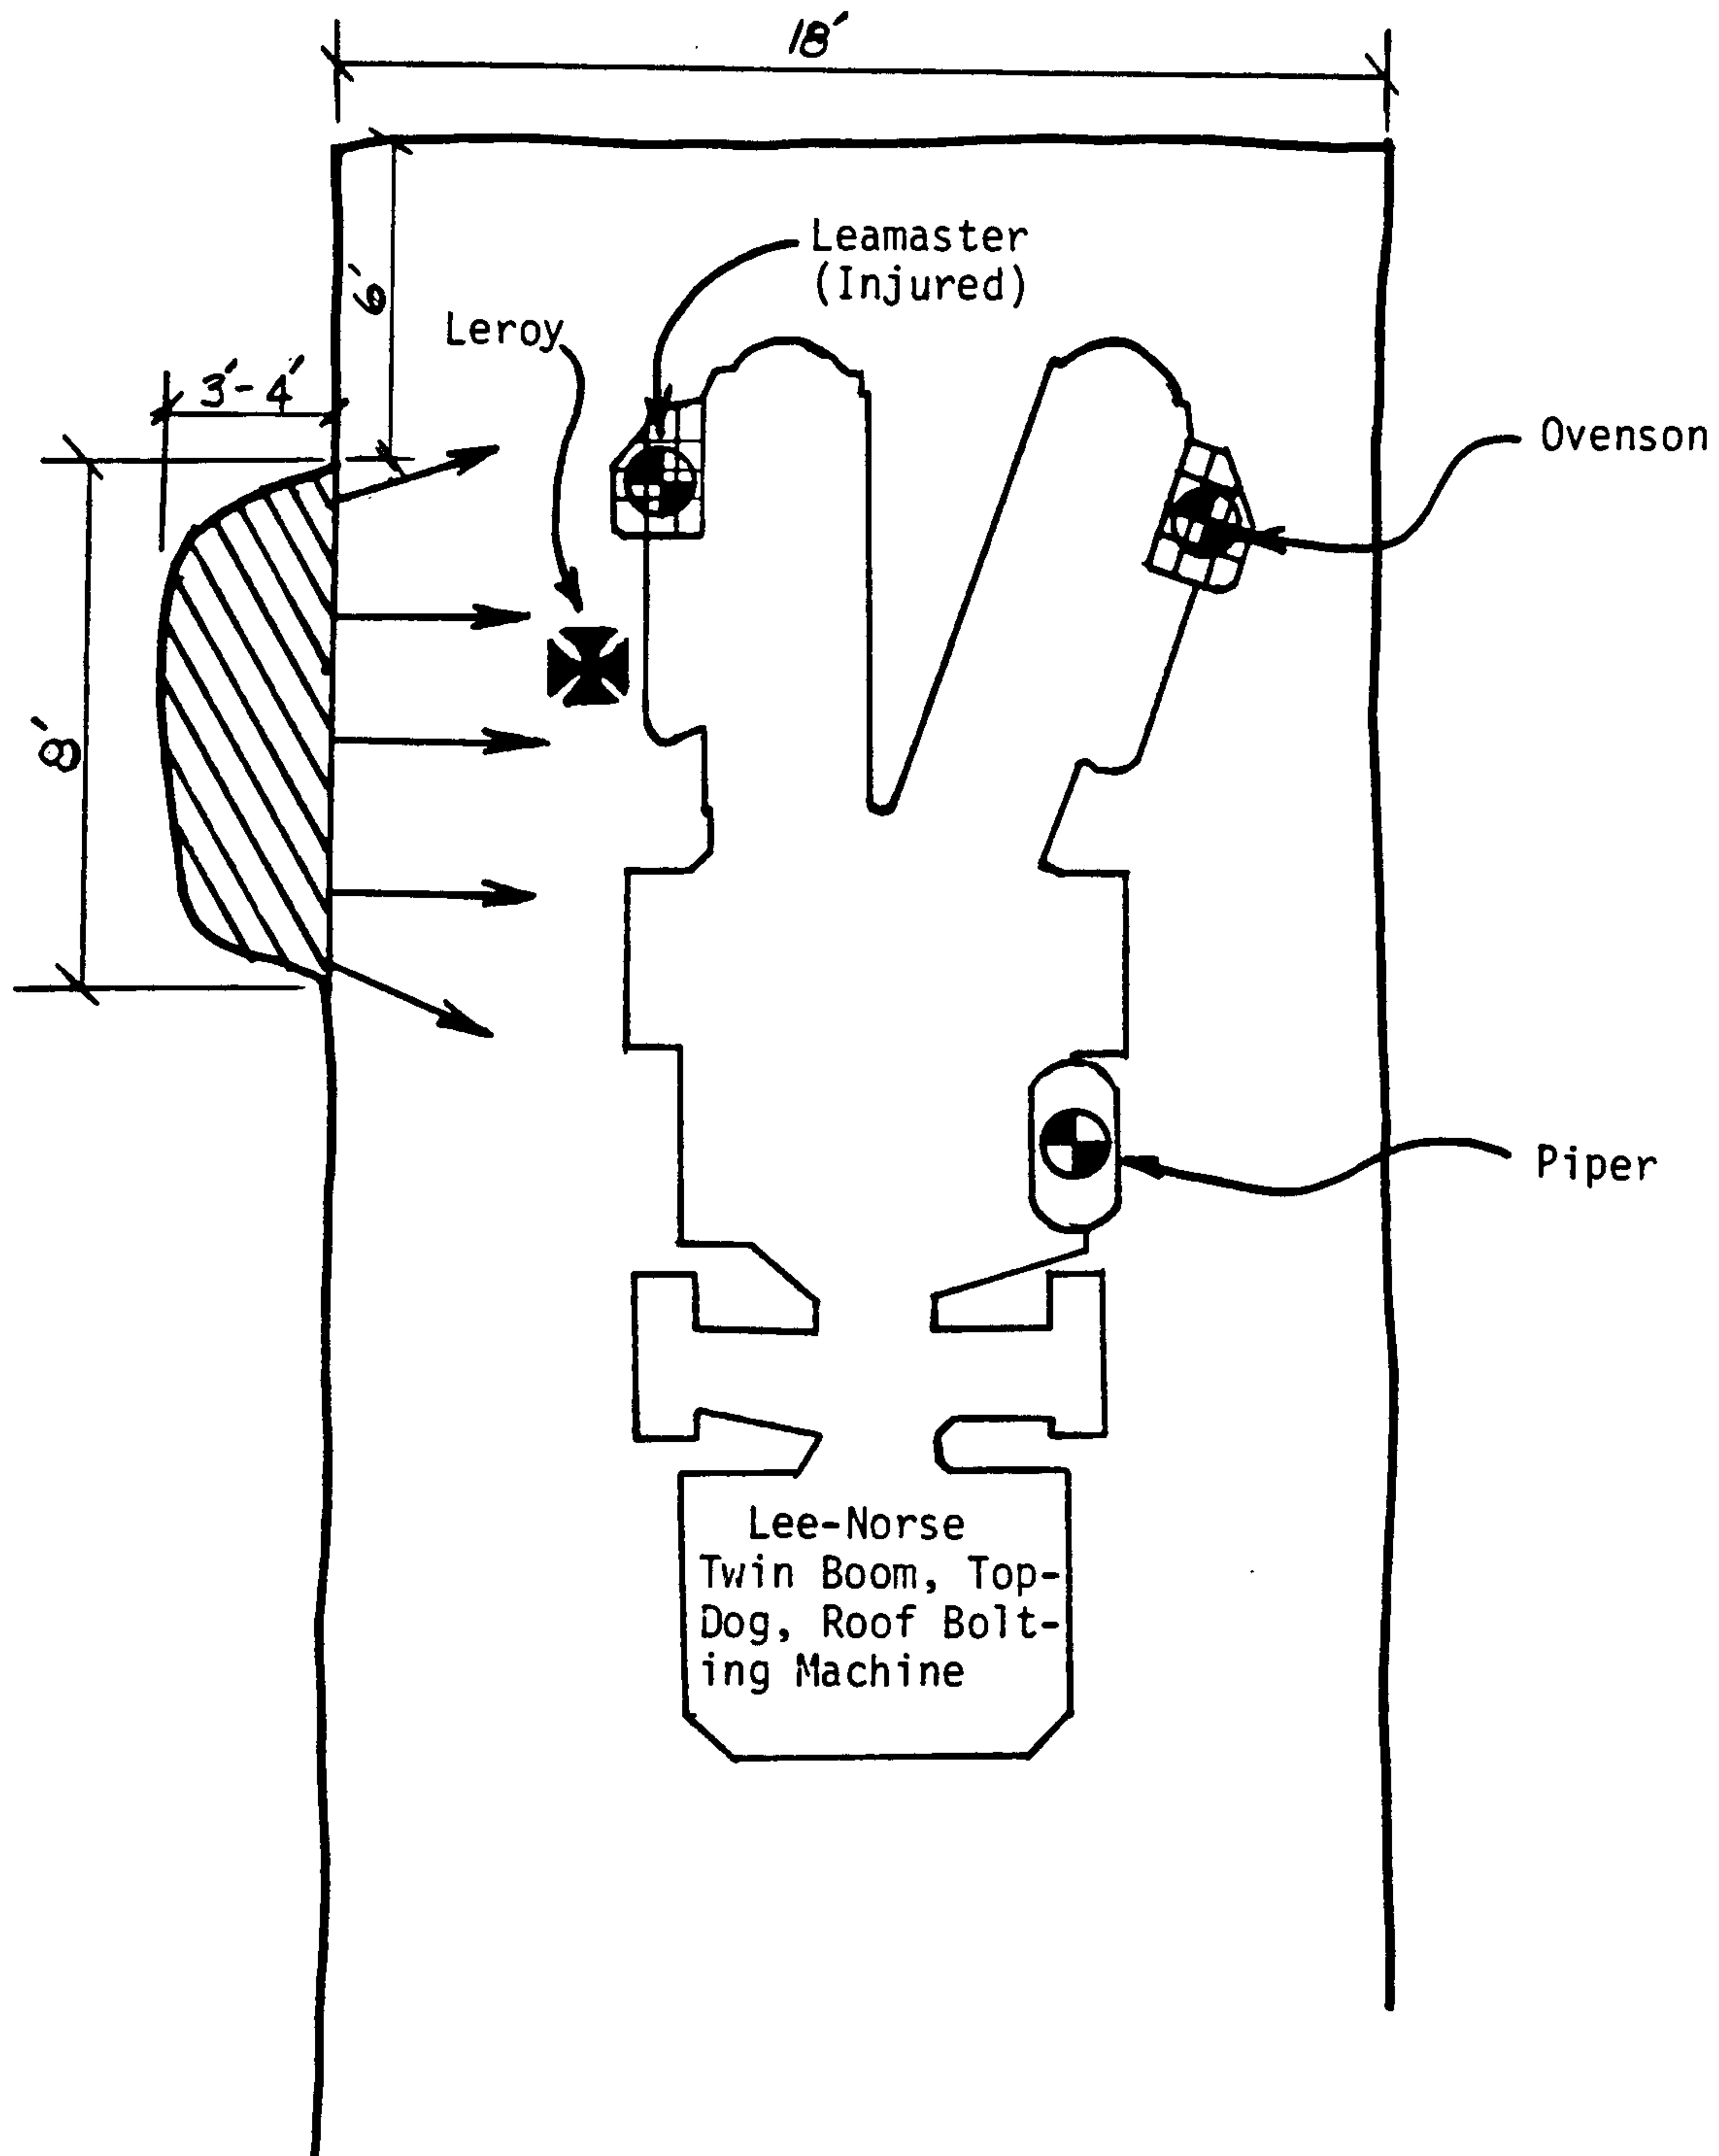
SKETCH OF FATAL
ROOF FALL (OUTBURST) ACCIDENT
Deer Creek Mine
Emery Mining Corporation
Huntington, Emery County, Utah

7. The outburst occurred on the left rib of the No. 2 room about six feet from the face. It measured eight feet in length, three to four feet thick, and about two to three feet high. The outburst occurred at the top of the rib and consisted mainly of the laminated shale from the top of the coal seam. Methane was not detected in the No. 2 room after the outburst.

The accident occurred due to excessive pressures on the barrier pillar from the 1400 feet of overburden, and the adjacent mined-out longwall panels. A contributing factor to the severity of the accident was the removal of the top coal and cap rock from the roof in the No. 2 room. This allowed the exposed cap rock in the rib to blow out when the outburst occurred.

8. The approved roof control plan was being followed in the No. 2 room at the time of the accident. During the investigation, the plan was amended to require that six foot long resin bolts with mats be installed on four foot centers in areas where cap rock was encountered, and 16 to 24 inches of top coal left in place as additional roof support.
